NORWALK RIVER BASIN
GEORGETOWN CONNECTICUT

FACTORY POND DAM CT 00217

PHASE I INSPECTION REPORT NATIONAL DAM INSPECTION PROGRAM

JULY 1980

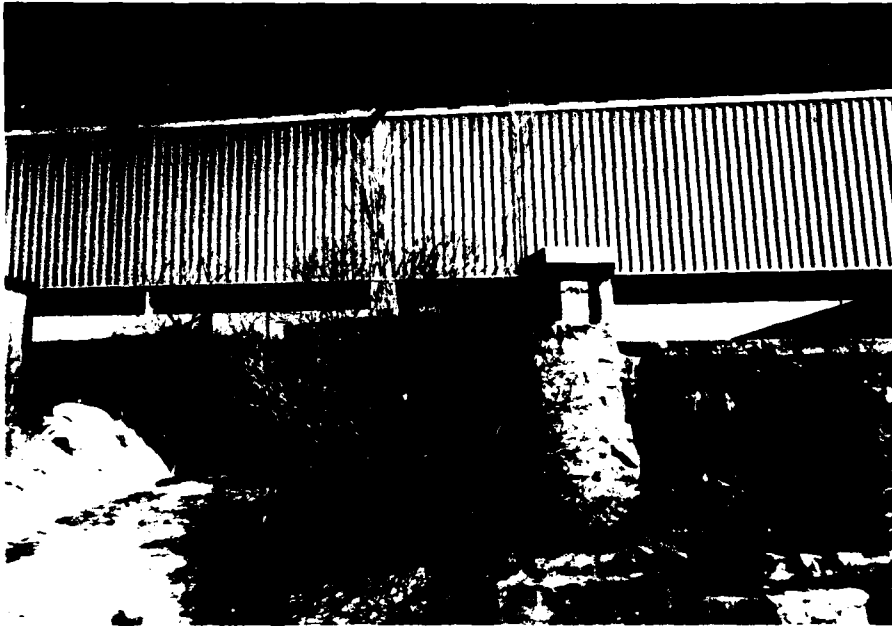
b. Dam - The dam is a combination of sheet piling/concrete fill and masonry. The sheet piling and concrete fill are in good condition (Photo 1). The sheet piling is painted with some areas that are rusting. The concrete cap is in good condition with no cracking (Photo 3). There is no evidence of settlement or lateral movement. There are some areas along the toe where vegetation is growing (Photo 1). The masonry portion of the dam is fair with some joints in need of repointing (Photo 8).

The spillway is a fixed weir that appears to be in fair condition (Photos 2 and 5). The downstream training wall and western abutment (Photos 1 and 6) show some seepage and cracks.

PHOTO 1
DOWNSTREAM FACE OF DAM

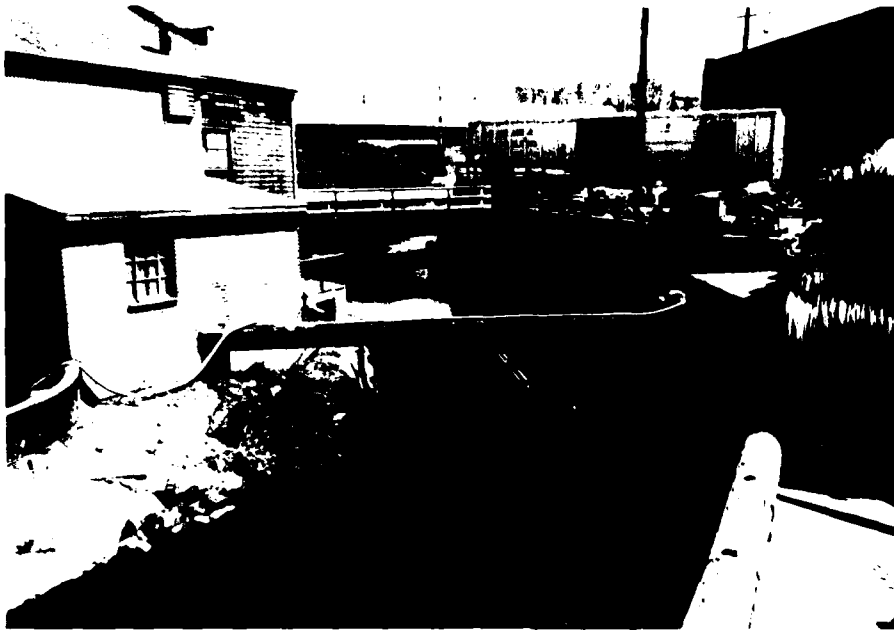
PHOTO 7
DOWNSTREAM CHANNEL
